HYDRAULIC INJECTION INCIDENT

A warning to us all

Aberdeen

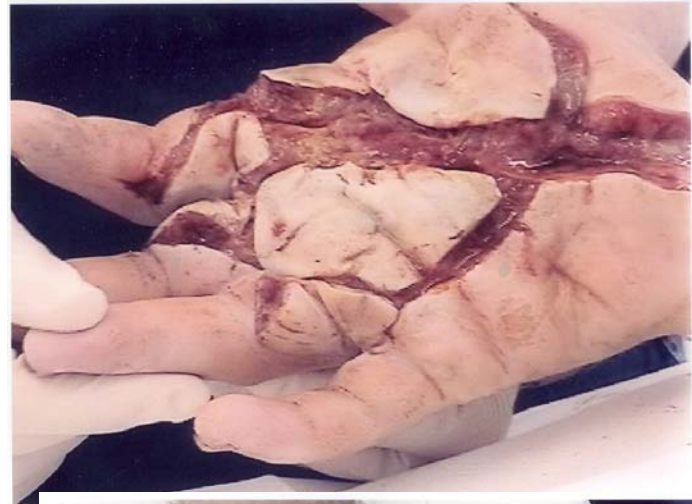
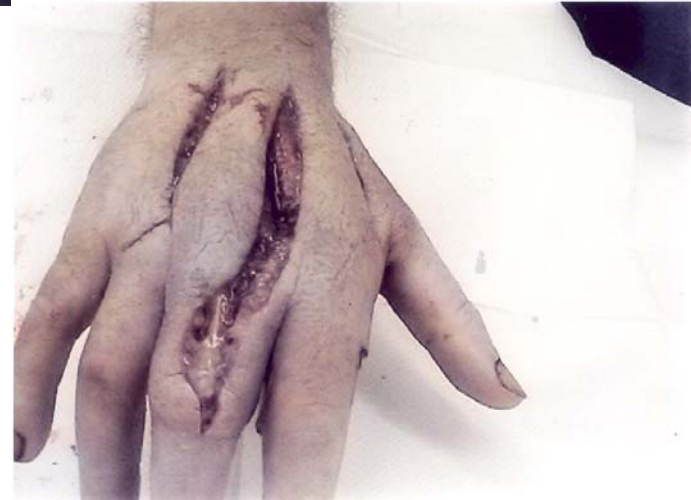
- Training Session under controlled conditions within Brigade Training Premises
- IP was to cut through sample vehicle using scissors.
- Normal practise at time was for the hydraulic hose to be run over operators shoulder to tool in use.
- Hose ruptured at ferrule area resulting in release of fluid through PPE (Leather gauntlets) to IPs hand.

- IP was eventually medically discharged from force and is severely disabled in this hand.
- Hydraulic Fluid in use has been changed to “Aero Shell Fluid 4”.
- Fire Brigade has passed learning's on to its associated Brigades.
- Litigation is in place:
 - IP to Brigade
 - Brigade to Equipment Manufacturers.
- IP awaits final outcome
- Timescale: 2 years and counting

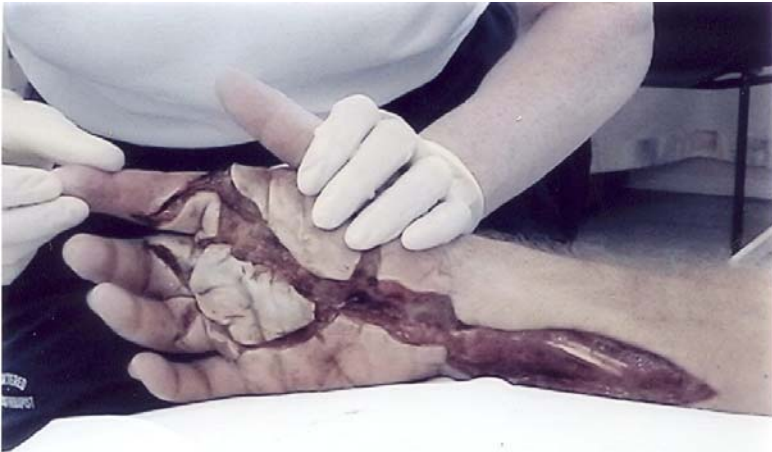
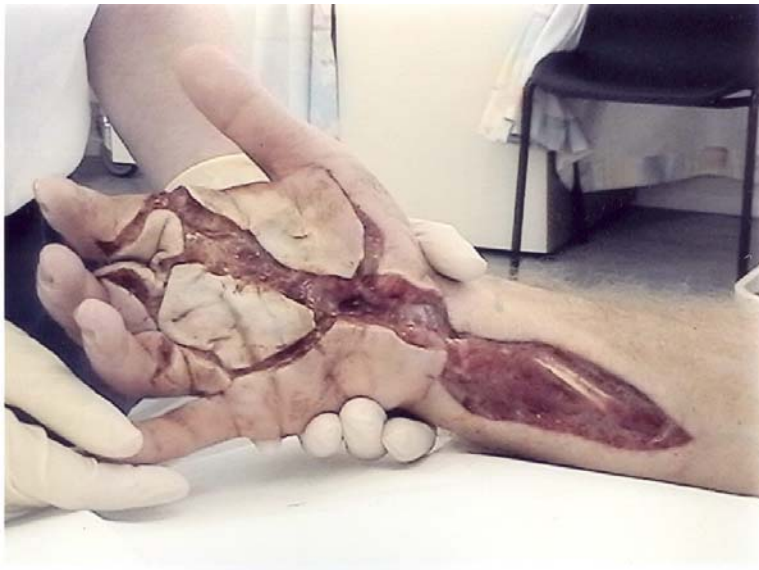
- IP went to A&E and initial prognosis was “keep clean and rest”.
- By chance a specialist observed and intervened.
- Mineral Oil had already started to “eat away” fatty tissues in hand and began travelling through the hand and up the arm.
- IP had 5 operations to cut away oil deposits and was on his last chance before losing arm. It was successful
- Wound could not be sutured due to tissue damage by oil so wound was gradually closed over weeks.
